November 15, 1962

## REPORT OF TEST [ ] ACTIVITIES - NON-VACUUM WINDOW

22 OCT. 62 - 5 NOV. 62

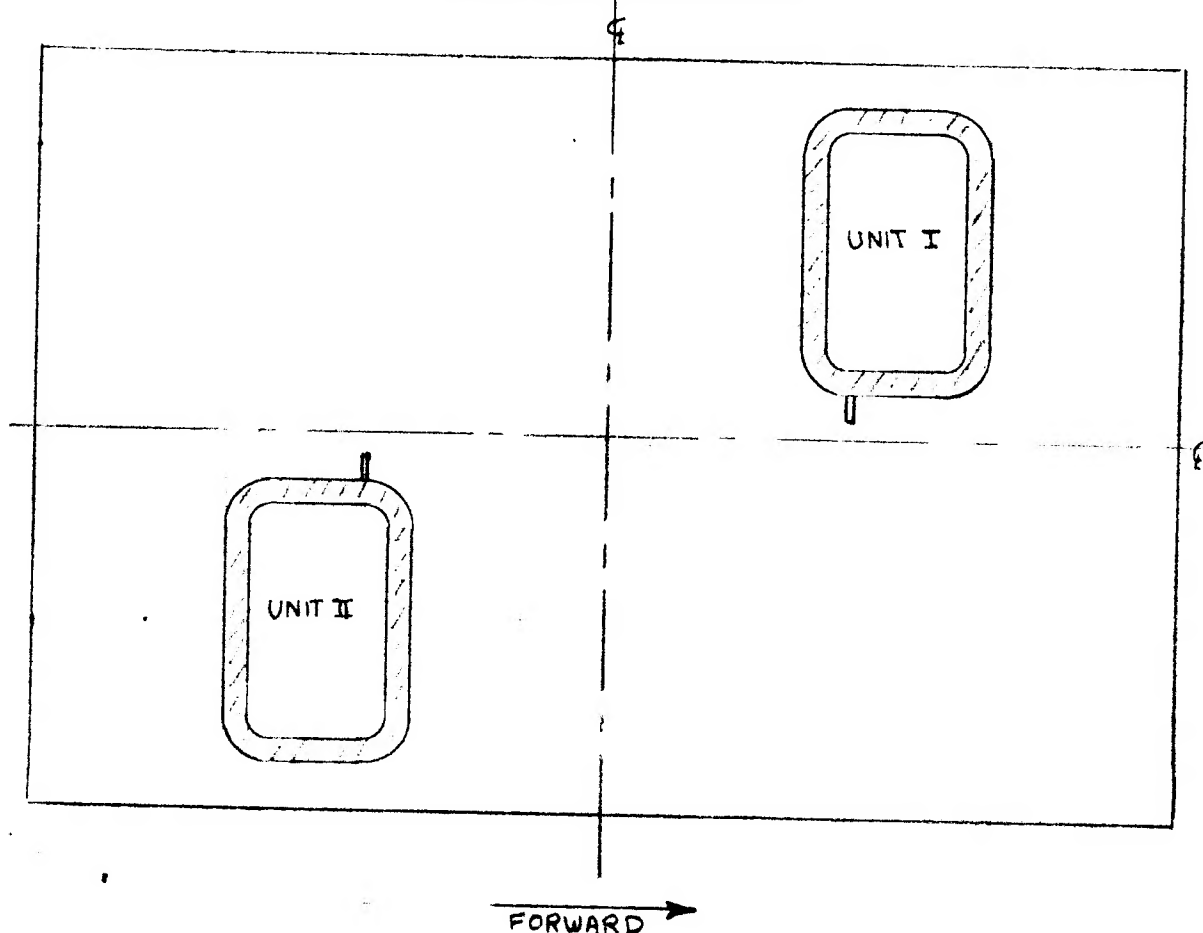
FIG 2

Measured temperature for the three test flights are summarized in Figures 2 through 4. For the mount and glass temperatures, the plotted points represent the average, as well as the high and low readings for eight mount thermocouples and seven glass thermocouples. Skin temperatures represent the reading of the thermocouple situated between the skin and the mount. Bay temperature represents the readings of the clock-type recorder located on the hatch.
